# **DOWNEY AIRPORT (HYDE MEMORIAL)**

Using the branch, section and sample unit divisions established, a visual condition survey was conducted at Downey Airport (Hyde Memorial) on November 05, 2006. During the inspection pavement defects were identified and measured in accordance with the methodology outlined in FAA AC:150/5380-6 and ASTM D5430. Our inspection ensures your airport complies with the “detailed inspection” requirement of FAA’s PMMP guidelines. After collection, the data were entered into the Micro PAVER software for analysis. These data are reproduced in the Re-Inspection Report attached in Appendix 2. Photographs of typical distresses observed during the inspections are provided in Appendix 3.

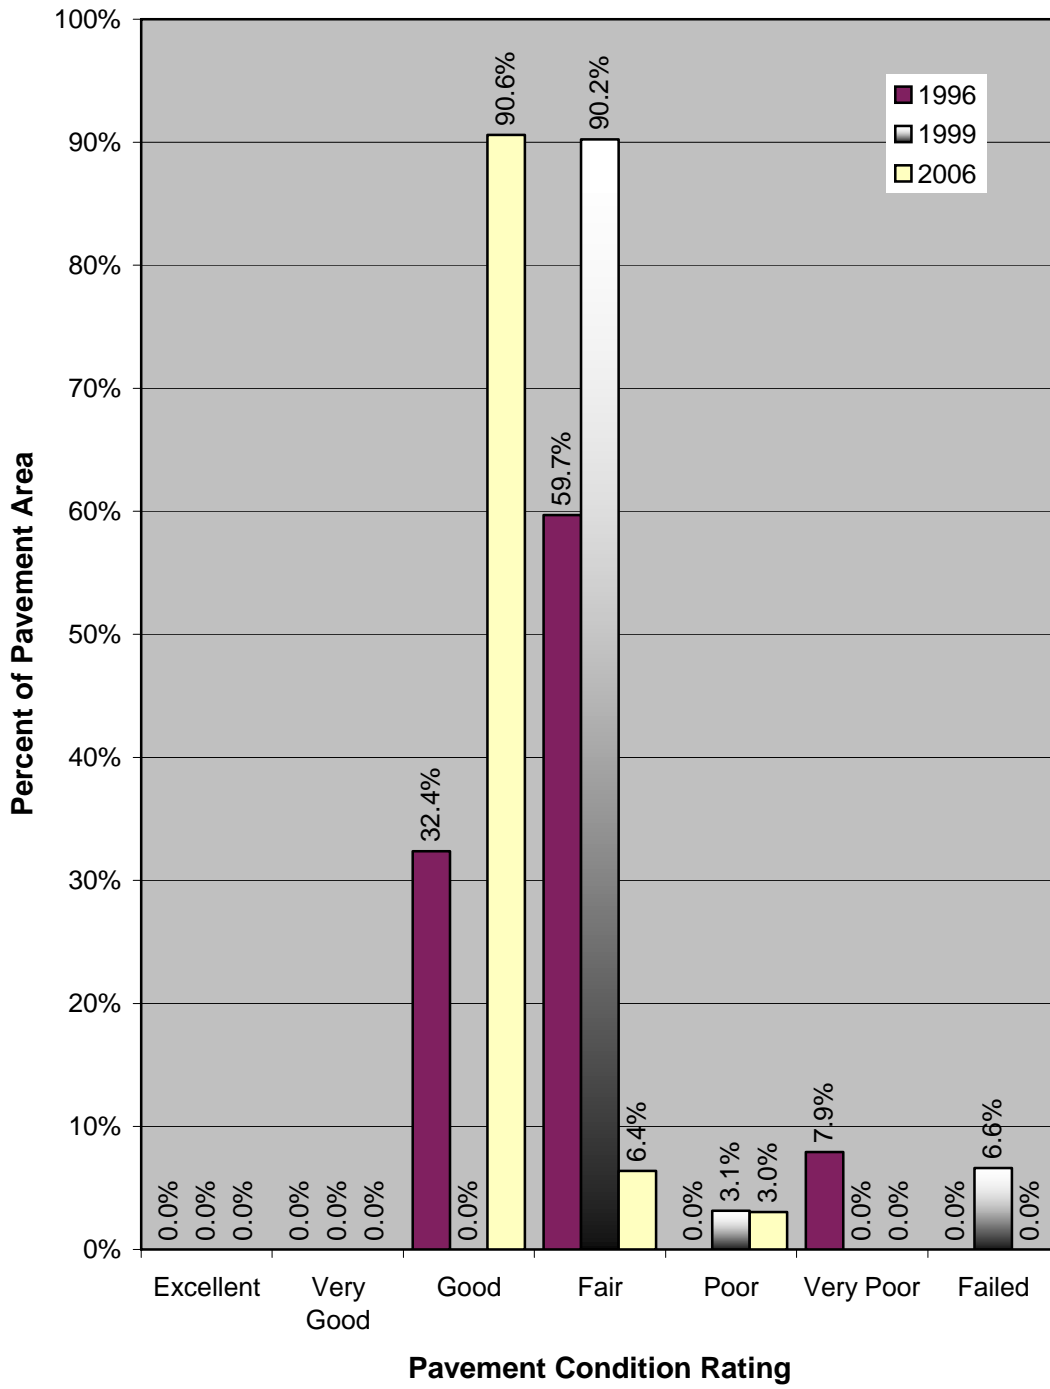
**Figure DO-4. Distribution of Pavement Condition  
Downey Airport (Hyde Memorial)**

Section PCIs at the airport range from a low of 18 (a PCR of “Very Poor”) to a high of 65 (a PCR of “Good”). The area-weighted average PCI for all airport pavements is 58, corresponding to an overall PCR of “Good”. Figure DO-4 shows how much pavement area is associated with each Pavement Condition Rating category and also shows pavement condition distribution from the inspections conducted in 1996 and 1999. A graphical representation of the projected PCRs presented in Table DO-2 is shown in Figure DO-5.

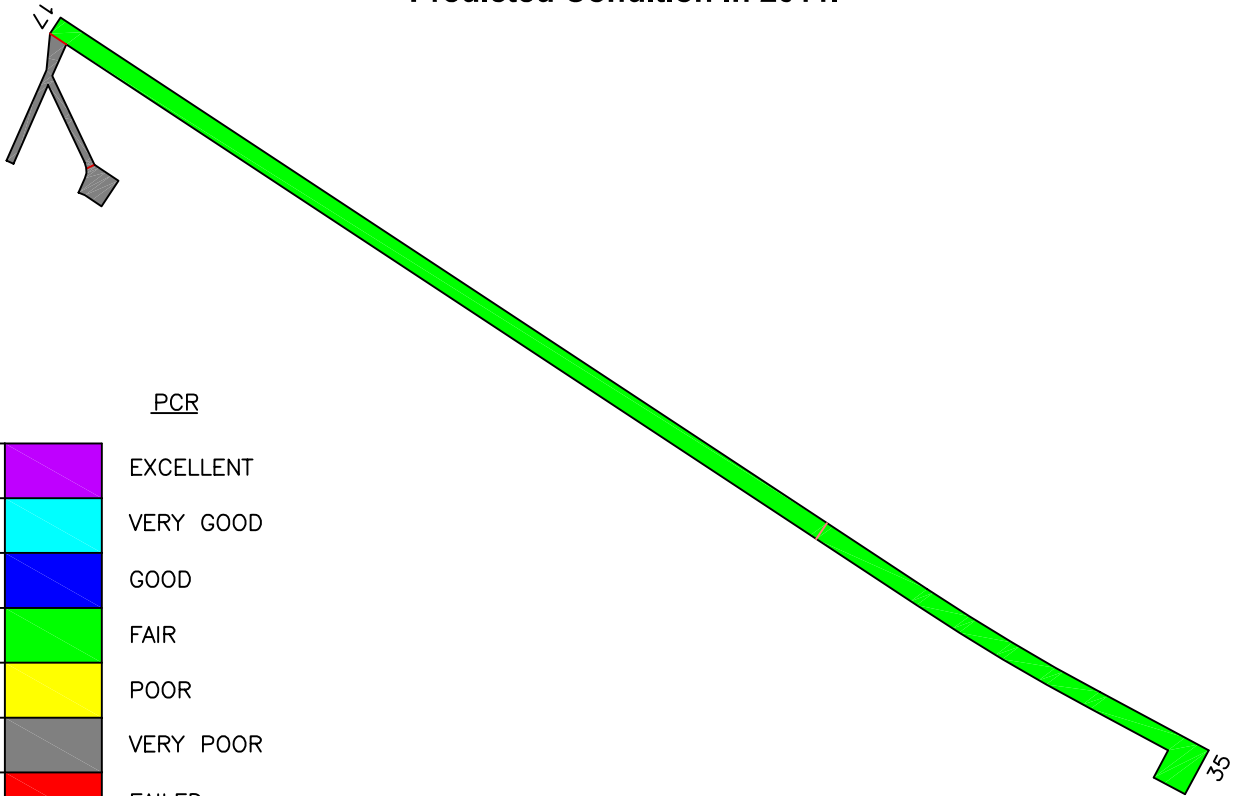
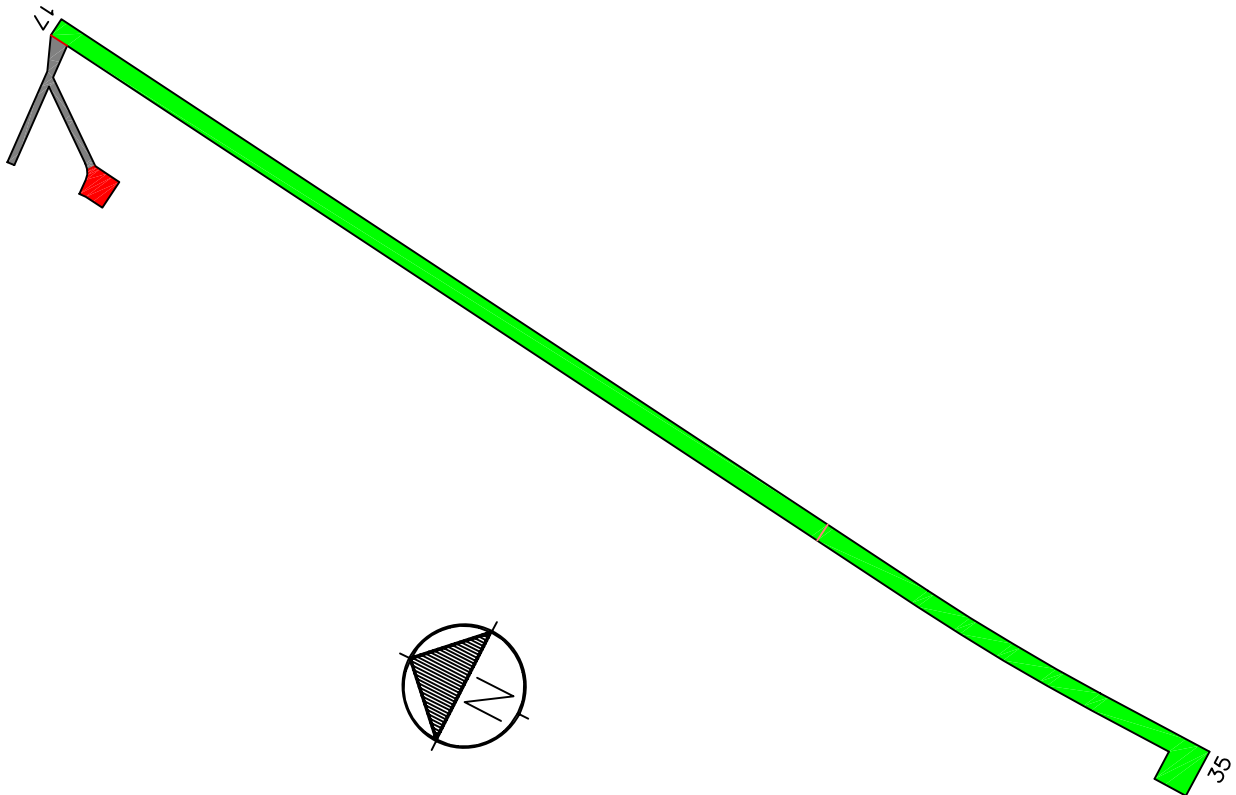
**Figure DO-5. Future Pavement Condition.**

Branch	Section	2006		2011		2016	
		PCI	PCR	PCI	PCR	PCI	PCR
A01DO	01	18	Very Poor	13	Very Poor	8	Failed
R17DO	01	60	Good	45	Fair	43	Fair
R17DO	02	65	Good	45	Fair	43	Fair
T01DO	01	29	Poor	25	Very Poor	21	Very Poor
